DEPARTMENT OF TRANSPORTATION**DIVISION OF ENGINEERING SERVICES**

Contract #: 04-0120F4Cty: SF/ALA Rte: 80 PM: 13.2/13.9File #: 1.28**WELDING INSPECTION REPORT****Resident Engineer:** Casey, William**Address:** 333 Burma Road**City:** Oakland, CA 94607**Report No:** WIR-028331**Date Inspected:** 04-Sep-2012**Project Name:** SAS Superstructure**OSM Arrival Time:** 700**Prime Contractor:** American Bridge/Fluor Enterprises, a JV**OSM Departure Time:** 1930**Contractor:** American Bridge/Fluor Enterprises, a JV**Location:** Job Site

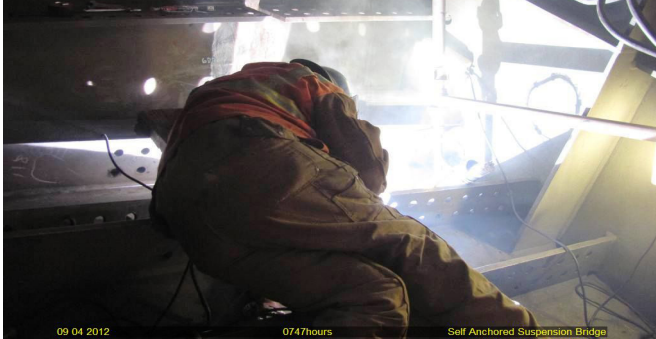
At OBG 12W/13W drop-in side plate C1.1 inside, QA randomly observed ABF/JV qualified welder Mike Jimenez continuing to perform CJP groove welding repair on a Seismic Performance Critical Member (SPCM) welded splice butt joint from Y=0mm to Y=2400mm per Caltrans approved Request for Weld Repair (RWR) # 201208-093. ABF personnel were noted using the Miller Proheat 35 Induction Heating System to preheat and maintain the required temperature of 325°F during welding. ABF welder Mike Jimenez was observed performing 3G (vertical) position utilizing Shielded Metal Arc Welding (SMAW) welding repair on welded splice butt joint. The welder was noted using 4.0mm E7018H4R electrode implementing Caltrans approved welding procedure ABF-WPS-D15-1004 Repair. ABF QC Barry Drake was also noted monitoring the welder with measured working current of 180 amperes Mike Jimenez. With the absence of ABF welder Rick Clayborn, Mike Jimenez continued 3G SMAW repair welding by himself till the end of shift wherein he was able to complete the repair. The welder held the preheat of 450°F for one hour after welding as required for the Post Weld Heat Treatment (PWHT).

At OBG 12W/13W-C1.1 drop-in side plate inside, ABF welder Mike Jimenez was observed continuing to perform 3G (vertical) position Shielded Metal Arc Welding (SMAW) welding repair from Y=0mm to Y=2400mm.

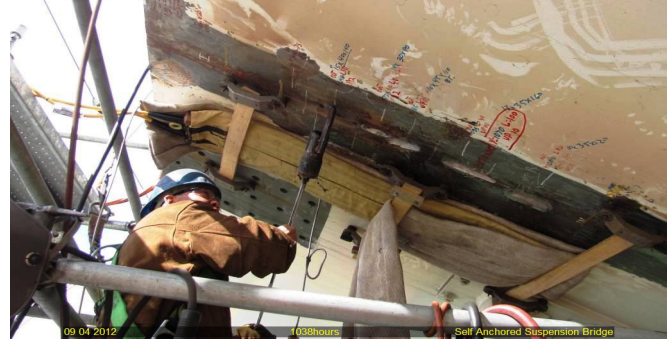
At OBG 12E-PP111.1-C1 drop-in side plate outside, QA randomly observed ABF/JV qualified welder Wai Kit Lai continuing to perform CJP groove welding repair at various locations Y=640mm, Y=725mm, Y=865mm, Y=1035 and Y=1070mm which were combined into one and Y=1240mm. These weld repairs are being repaired per Caltrans approved Request for Weld Repair (RWR) #201208-089. The welder was observed manually welding in the 4G (overhead) position utilizing Shielded Metal Arc Welding (SMAW) with 3.2mm diameter E7018H4R electrode implementing Caltrans approved welding procedure ABF-WPS-D15-1004 Repair. The first time repairs which have cumulative length of 1050mm against total weld length of 2275mm were preheated to more than 225 degree Fahrenheit using Miller Proheat 35 Induction Heating System with the heater blanket put in place on one side of the weld joint prior/during excavation. During the shift, ABF QC Salvador Merino was noted monitoring the welder with measured working current of 116 amperes on the 3.2mm E7018H4R electrode and adjusted preheat temperature of 325°F during welding. The welder performed the Post Weld Heat Treatment (PWHT) of 450°F and held it for one (1) hour after welding as required where the weld repairs were completed. The following first time repairs were noted excavated and welded during the shift;

1. 640mm 140mm 40mm 15mm R1 - completed.
2. 725mm 90mm 30mm 15mm R1 – completed.

3. 865mm 110mm 45mm 10mm R1 – completed.
4. 1035/1070mm 160mm 35mm 13mm R1 –combined/completed.
5. 1240mm 120mm 35mm 11mm R1 – excavated.

At OBG 12E-PP111.1-C1 drop-in side plate outside, ABF welder Wai Kit Lai was noted preheating the weld repair area and its vicinity using propylene gas torch in addition to the Miller Proheat 35 Induction Heating System being used during welding.

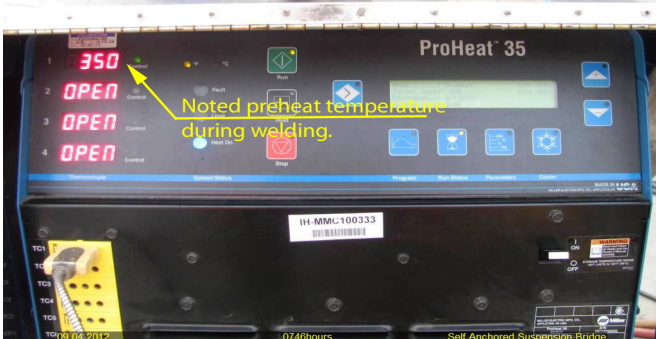
At OBG 12W/13W-C1.1 drop-in side plate inside, ABF personnel were noted using the Miller Proheat 35 Induction Heating System to preheat, maintain and PWHT the weld repair being welded from Y=0mm to Y=2400mm.

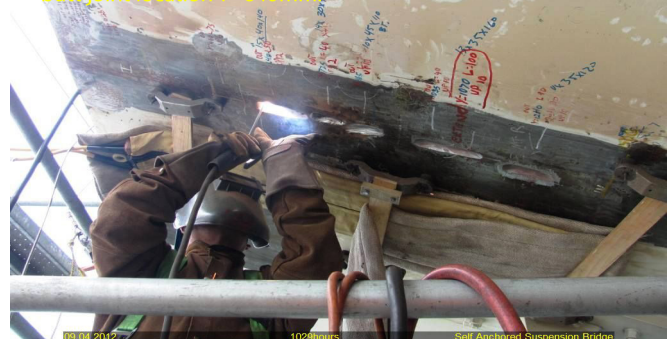
At OBG 12E-PP111.1-C1 drop-in side plate outside, ABF welder Wai Kit Lai was observed performing 4G (overhead) position Shielded Metal Arc Welding (SMAW) welding repair on welded butt joint location Y=640mm.
